# Manhole Inspection Summary

Manhole # S51C\_\_022MH

Insp Date: **5/2/08 1:33 PM**

**Location** Address: **37 e fairmount ave**

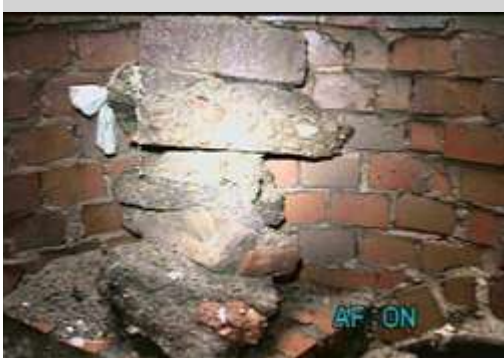
misc bench debris

bench debris

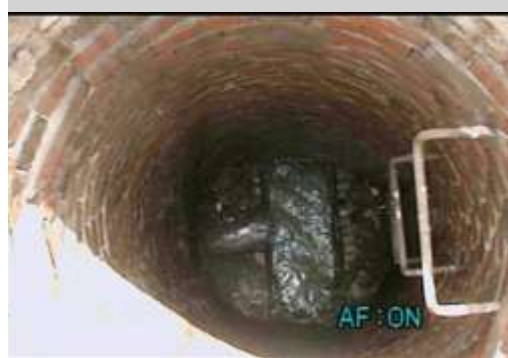
Defect 1

Condition: ☐ Sound ☐ Cracked ☐ Root Intrusion ☒ **Loose Brick** ☐ Deteriorated

Count: **7** Missing: **0** ☒ **Corroded**

loose bricks, steps

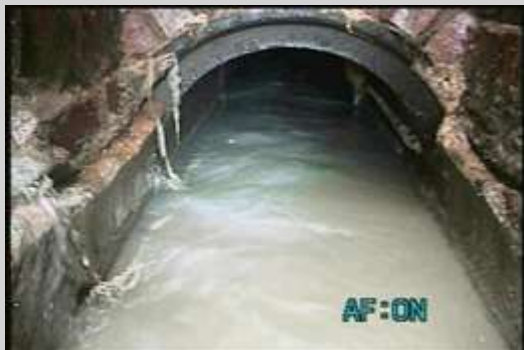
12 O'Clock Outflow

18 in. Circular Gravity Sewer  
Pipe Out @ 12 O'Clock

Invert Depth: **14.52** (ft.) Flow Characteristics: **Fast**

Infiltration: **None** Pipe Seal Cond: **Unknown**

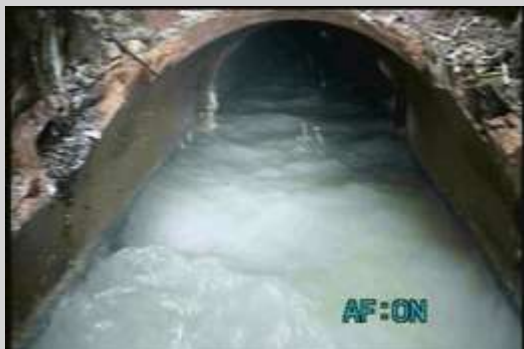
6 O'Clock Inflow

18 in. Circular Gravity Sewer  
Pipe In @ 6 O'Clock

Invert Depth: **14.50** (ft.) Flow Characteristics: **Fast**

Infiltration: **None** Pipe Seal Cond: **Unknown**

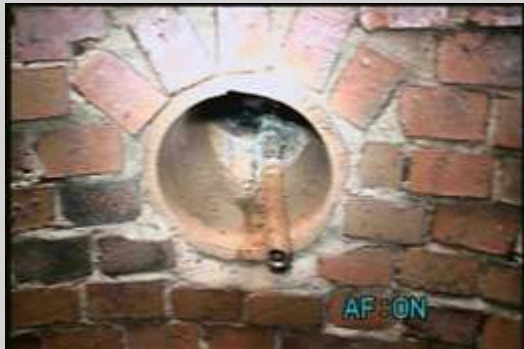
9 O'Clock Inflow

Pipe In @ 9 O'Clock

Invert Depth: 9.10 (ft.) Flow Characteristics: Fast

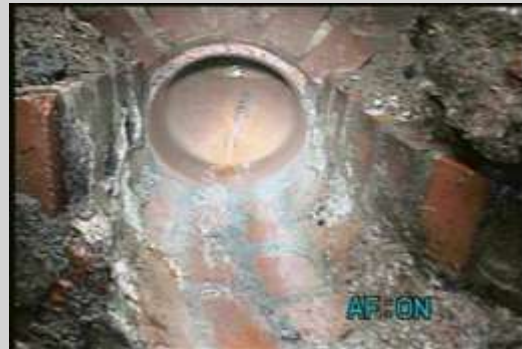
Drop In @ 9 O'Clock

Drop: Outside Direct

Inv Depth: 12.81 (ft.)

Drop Condition: Open
